# Selling Arguments *for* TIN ROOFING

*A review of the advantages of  
roofs of this type*

A textbook containing corrected tables for use in estimating, instructions for laying tin roofs, description of the manufacture of roofing tin, and a large amount of information useful to the practical man.

N. & G. Taylor Company, Philadelphia

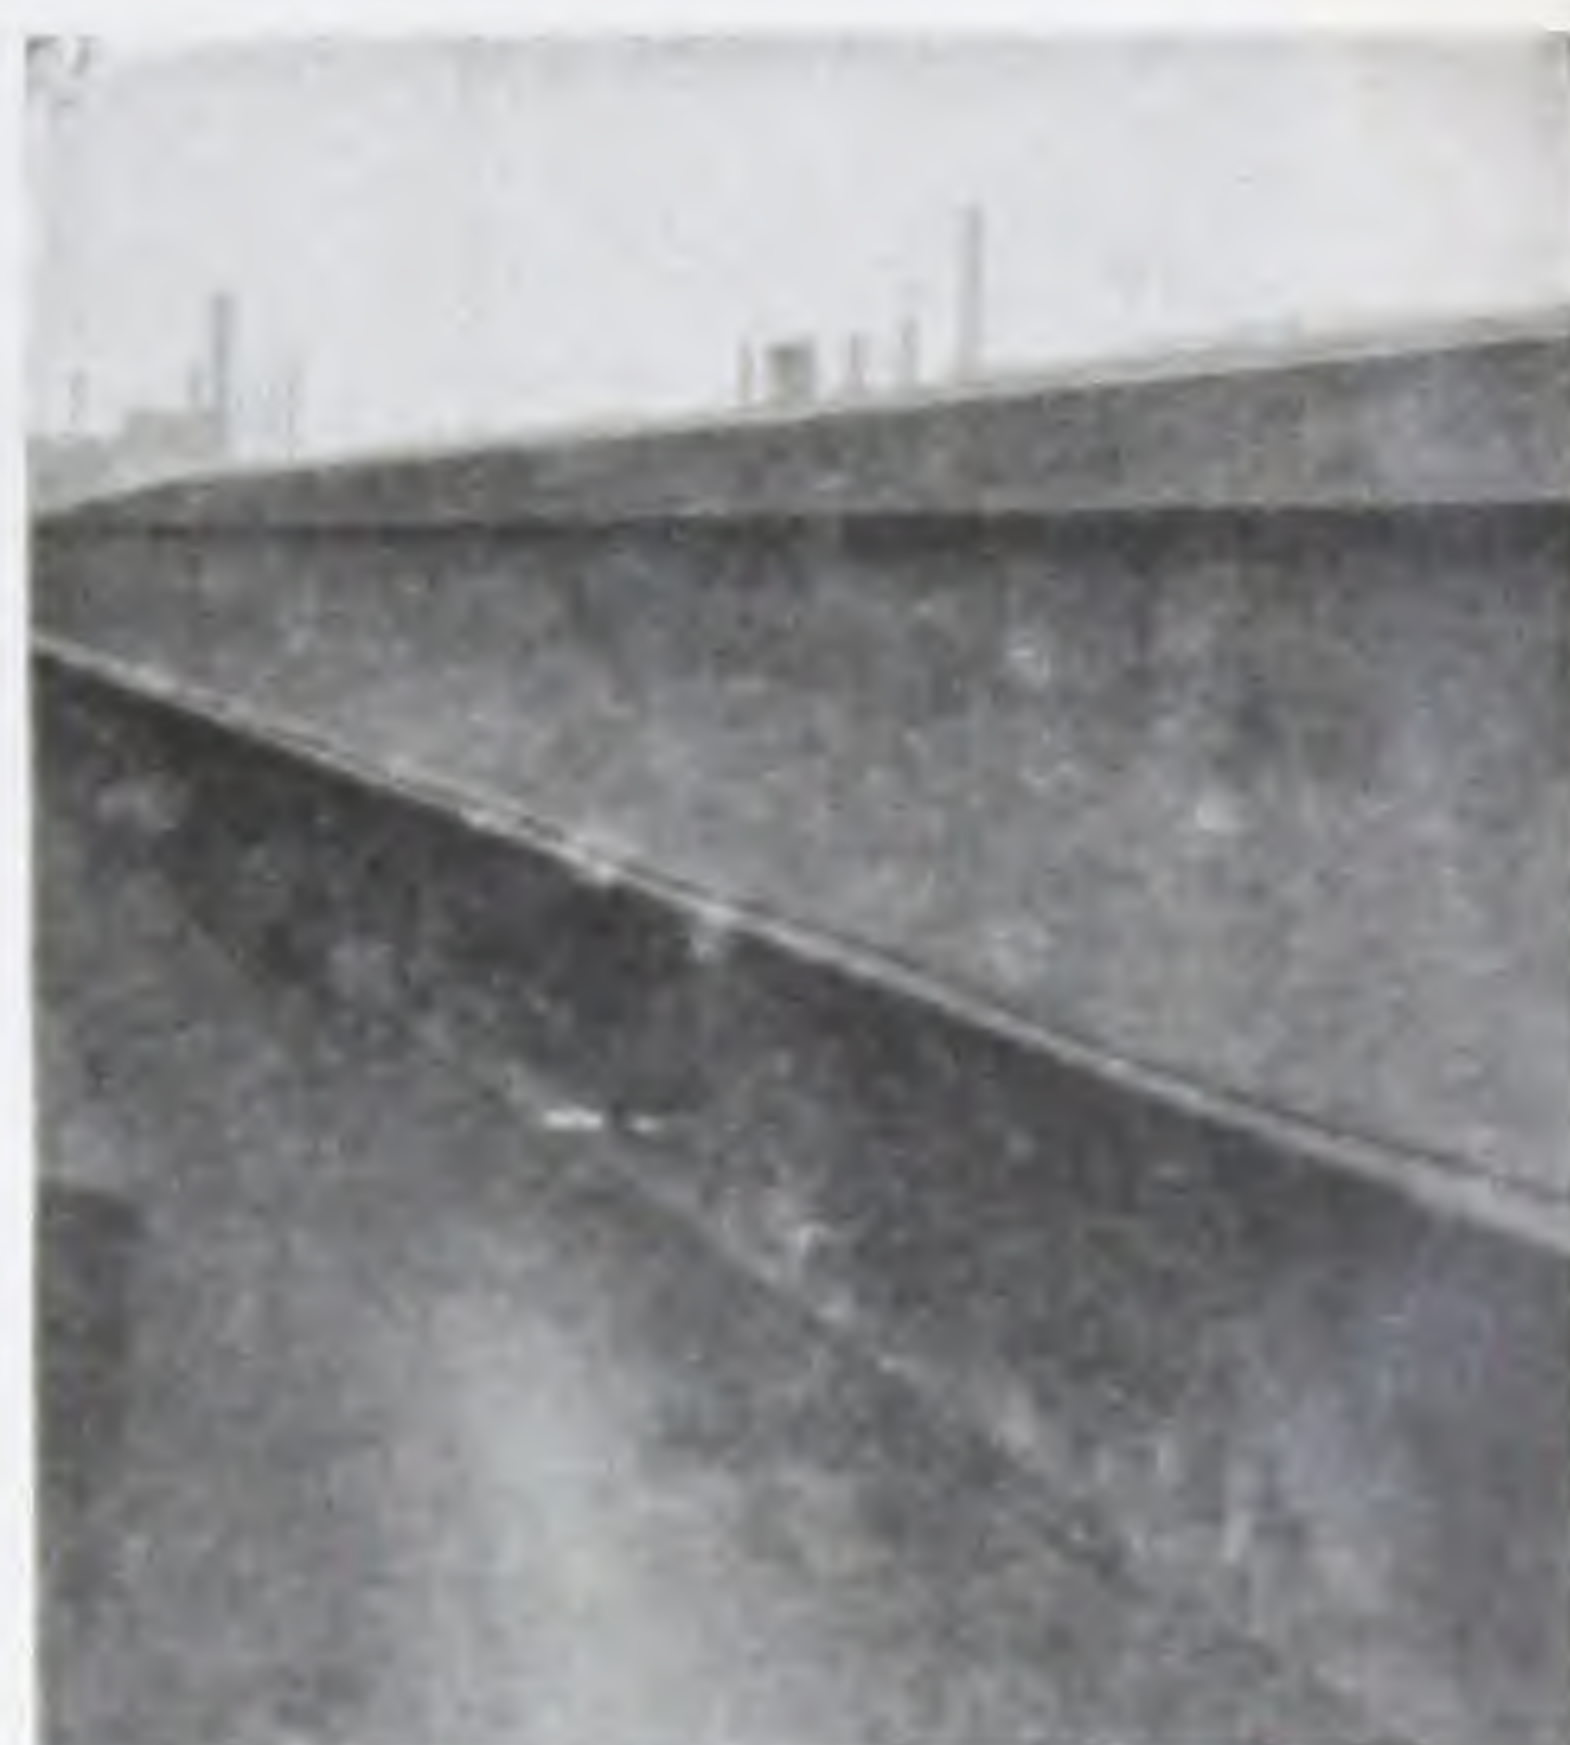
**11. DURABILITY:** Freight station, C. B. & Q. Railroad, St. Louis, Mo. Covered with our tin in 1890. Five railroad tracks enter this building, and the roof is exposed constantly to the smoke of locomotives. The tin is laid with standing seams, on narrow tongued and grooved sheathing-boards. Roof in first-class condition, and apparently good for many years to come.

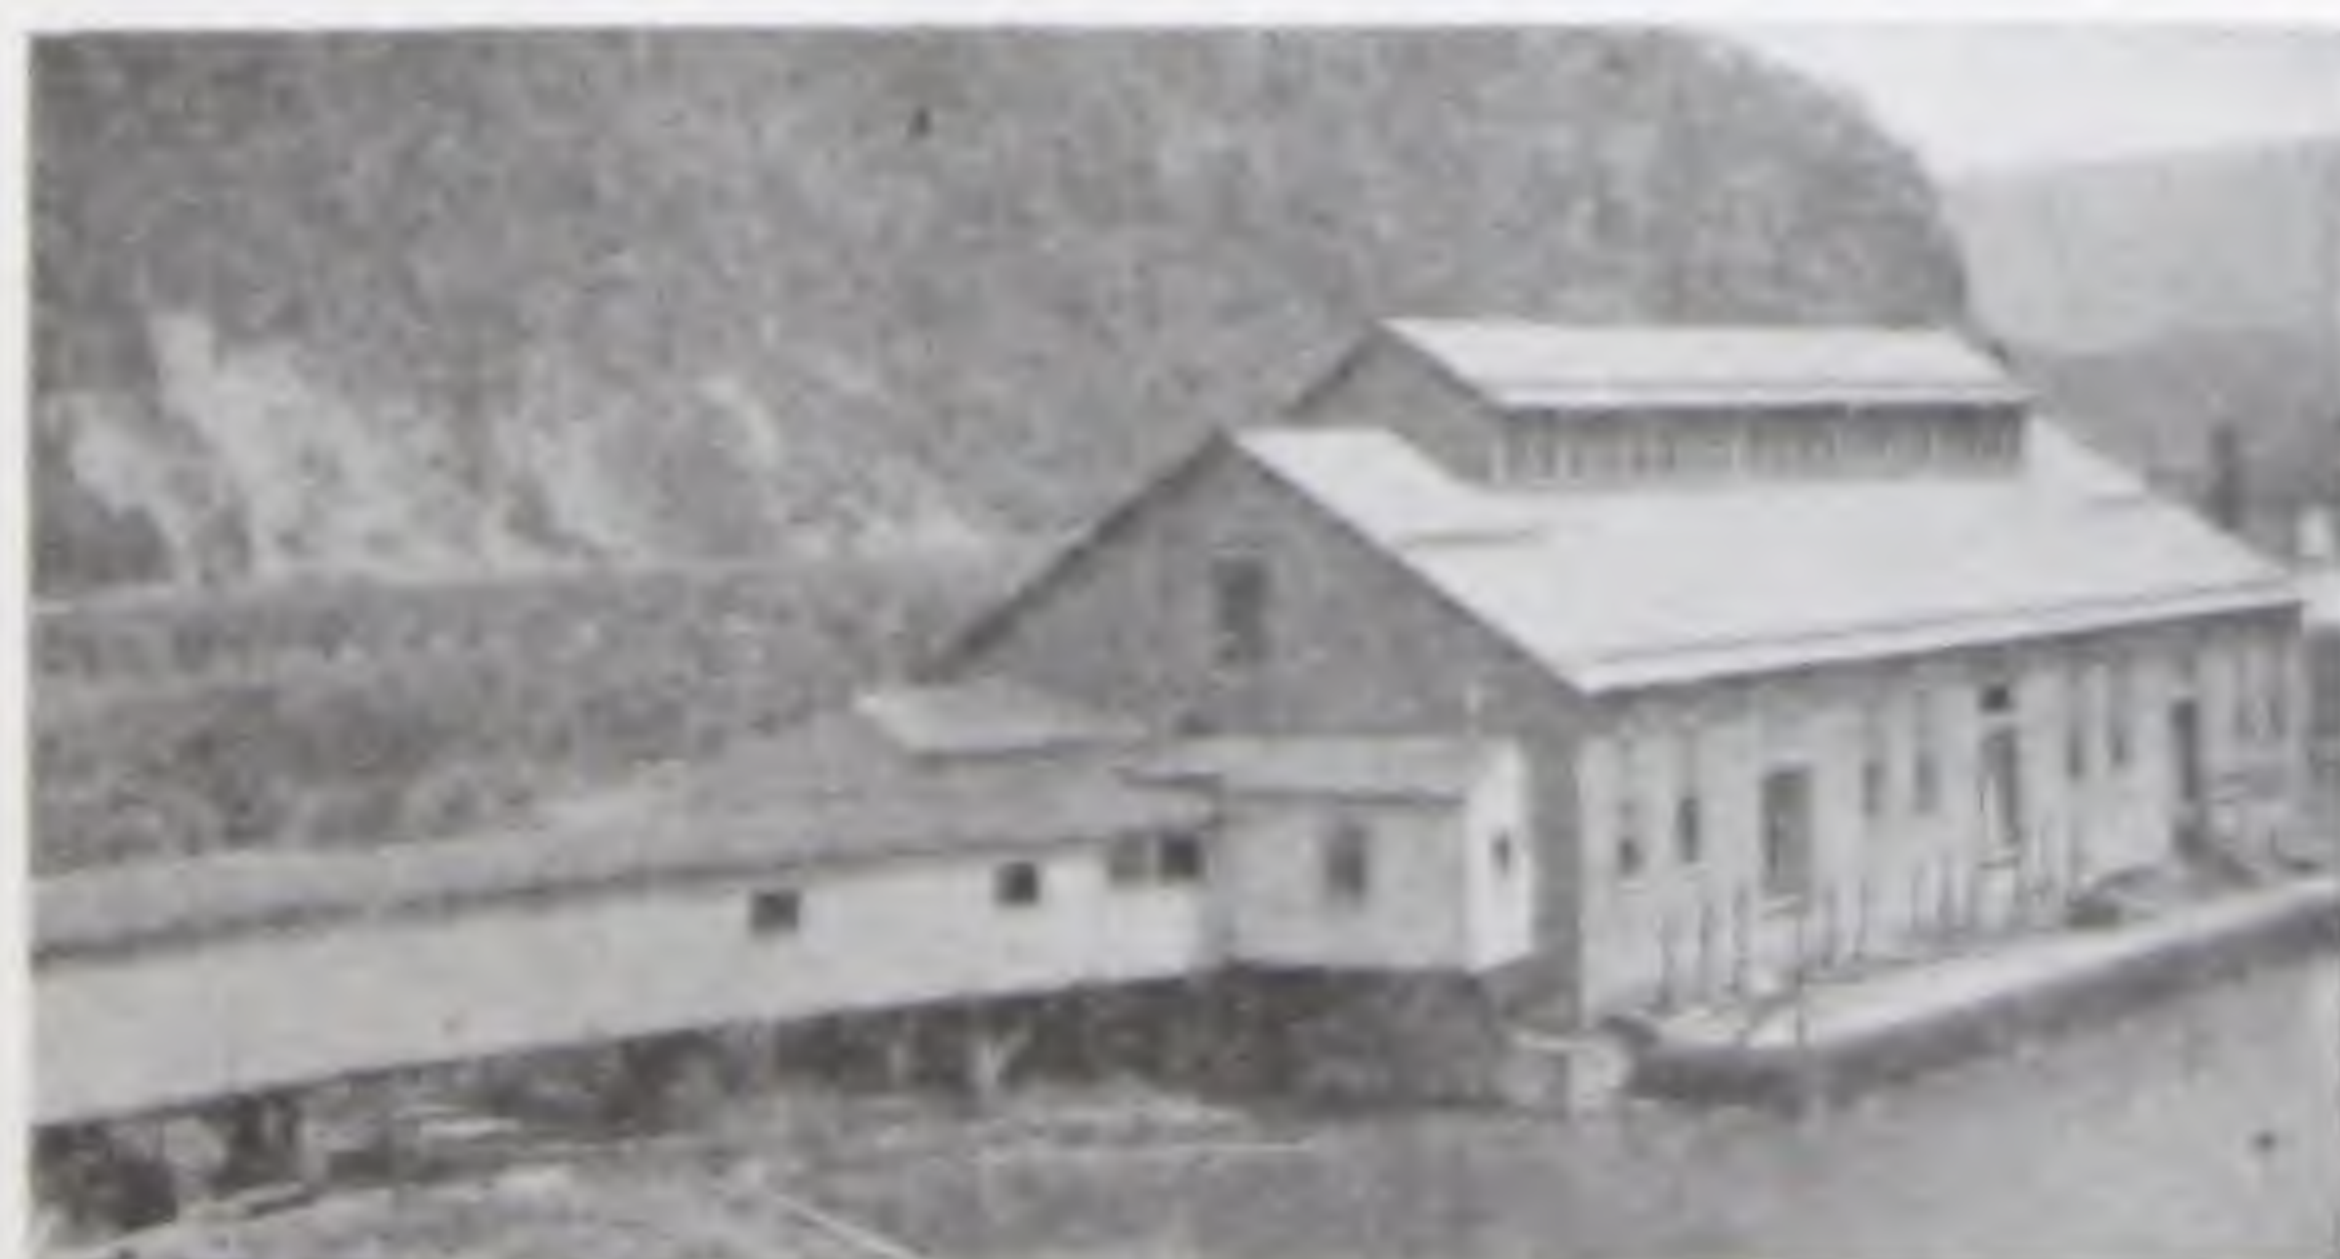
**13. DURABILITY:** Paper pulp mill at Harper's Ferry, W. Va. Situated within a stone's throw of the ruins of the historic John Brown's Fort. Between 1883 and 1907 three ordinary roofs proved their inability to stand the warm steam atmosphere beneath them and the wear and tear from sweeping accumulated sawdust from their surfaces. In the latter year a Target and Arrow roof was put on, and after thirteen years remains in first-rate condition, evidently good for many years to come. This building is directly alongside the main line of the Baltimore & Ohio Railroad, with passenger and freight trains constantly passing it.

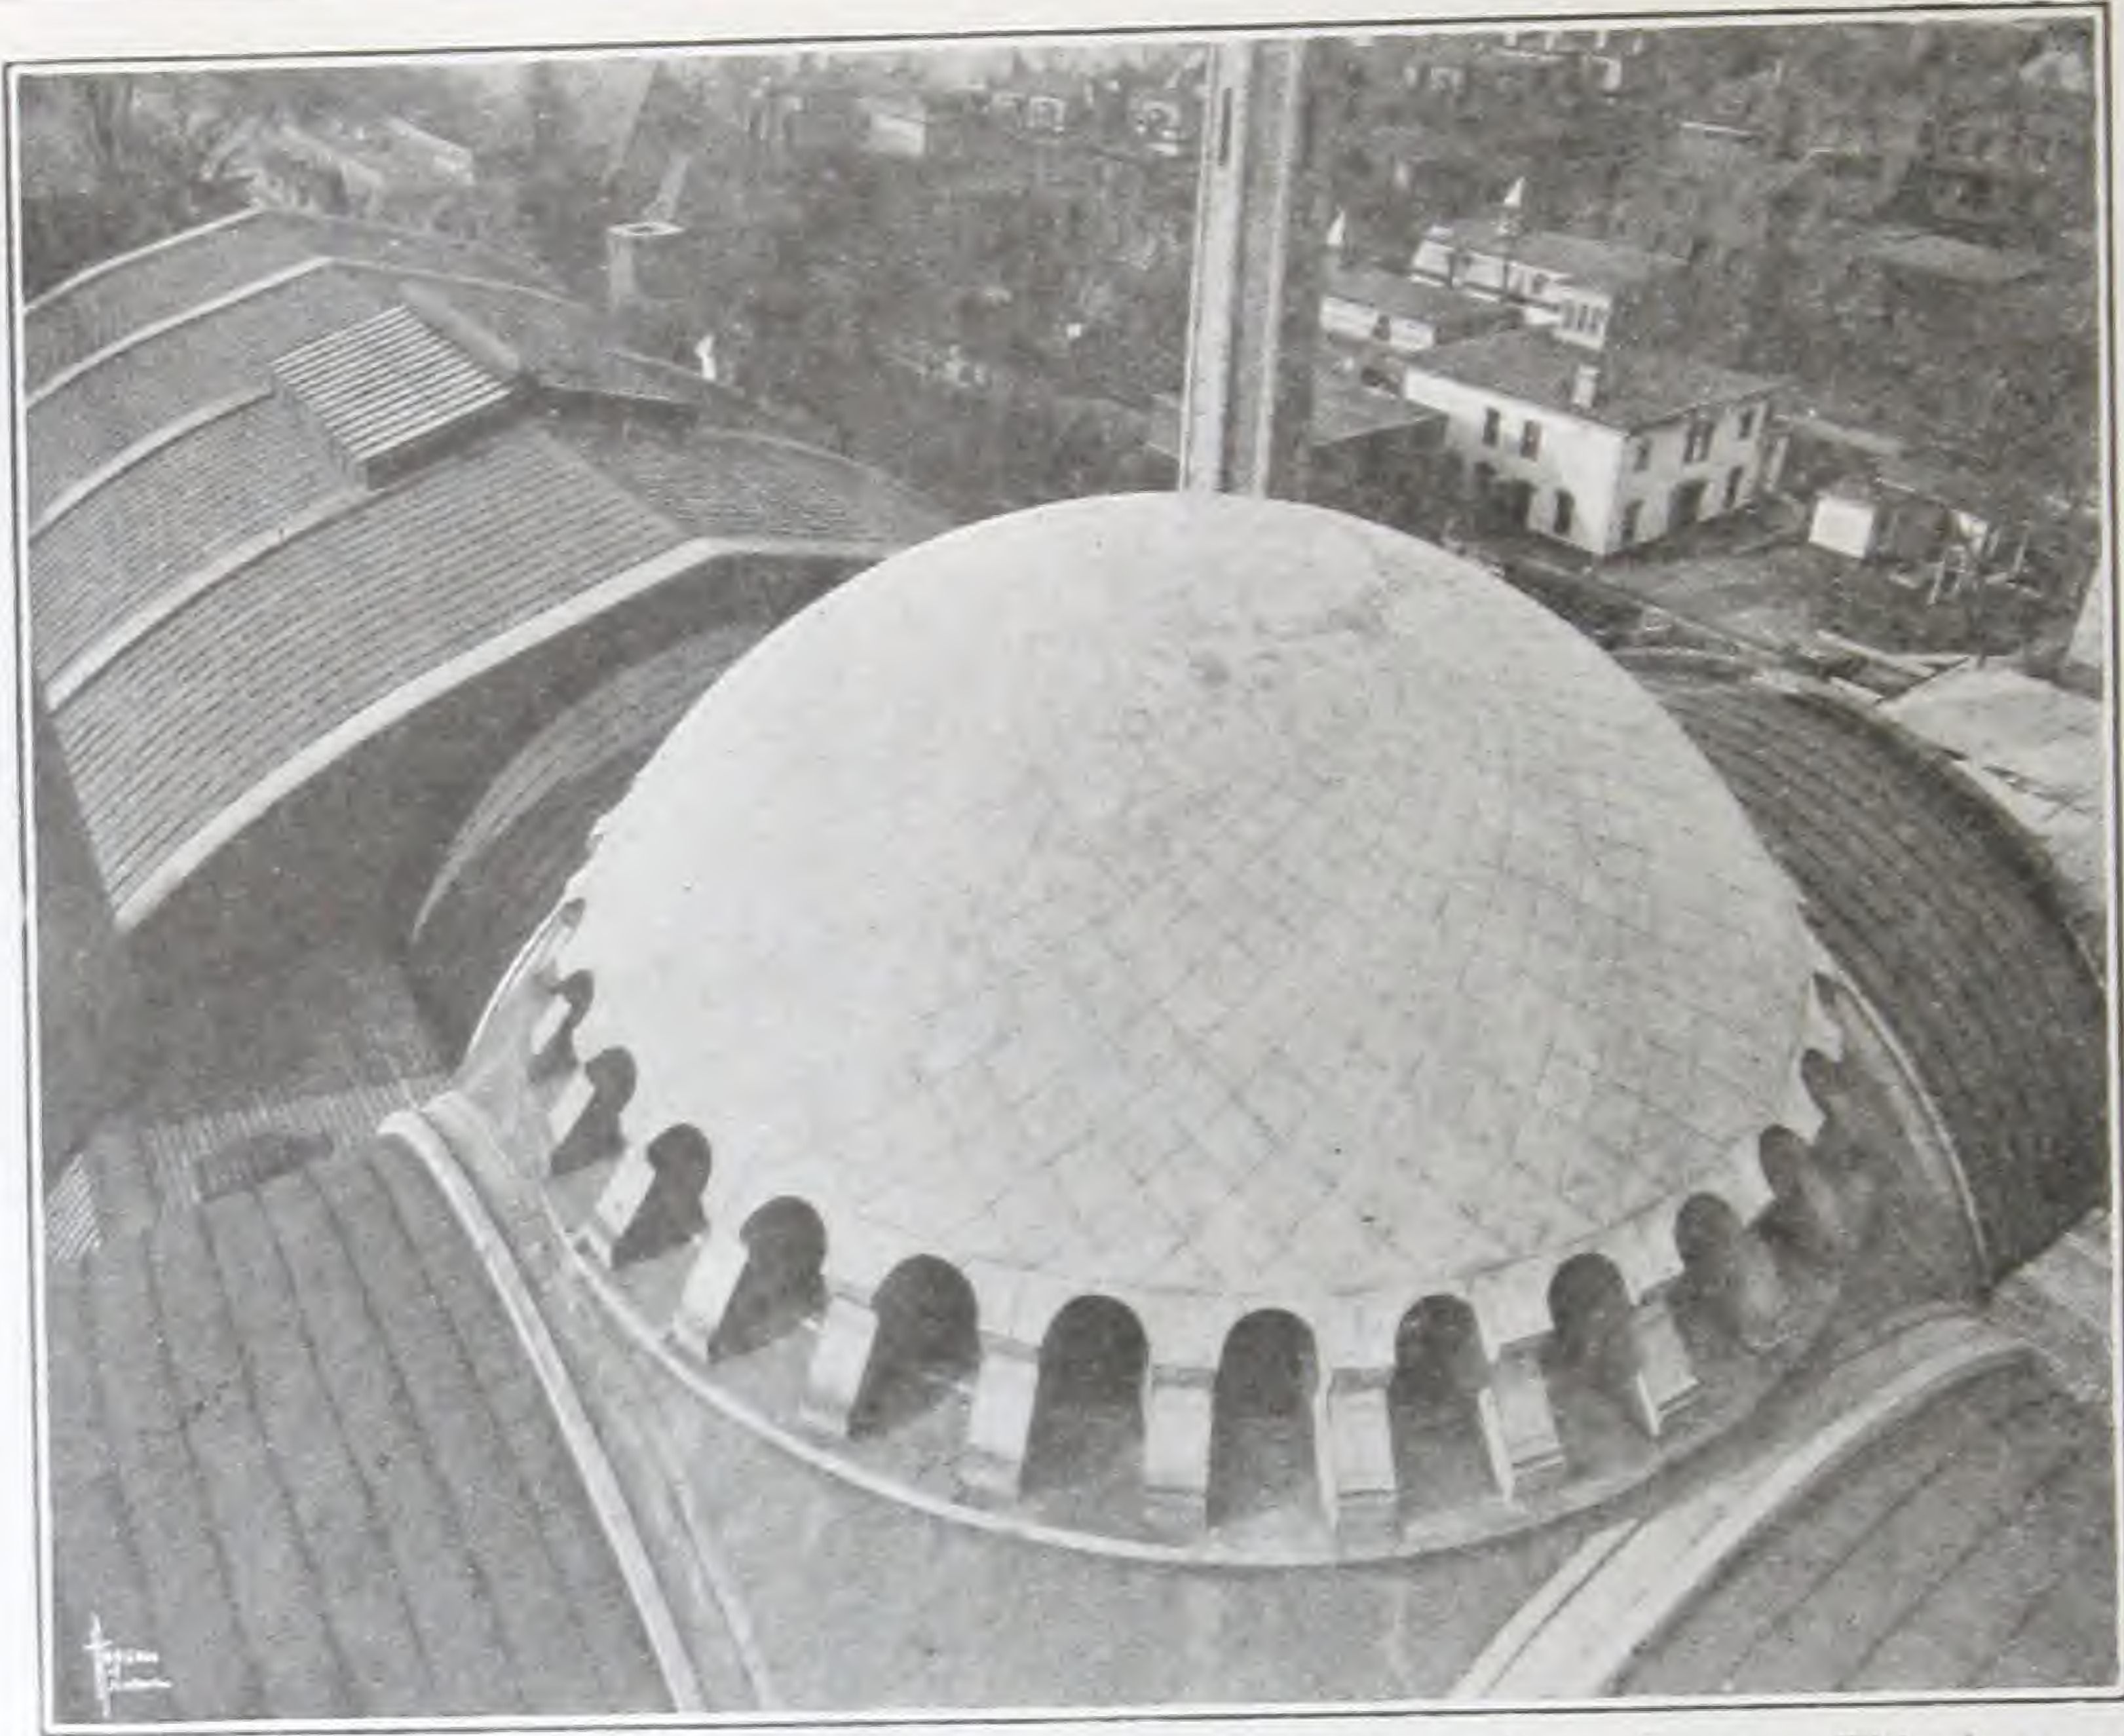
**14. ADAPTABILITY:** This view shows the Irem Temple at Wilkes-Barre, Penna. This dome and all surrounding roofs of the building are covered with 15,000 sq. ft. of our best tin, put on in the fall of 1909. In covering the dome the sheets were cut square, decreasing in size from bottom to top. By using good tin a large item of expense was saved, which would otherwise have been required for a concrete dome, and a far more satisfactory roof was secured.

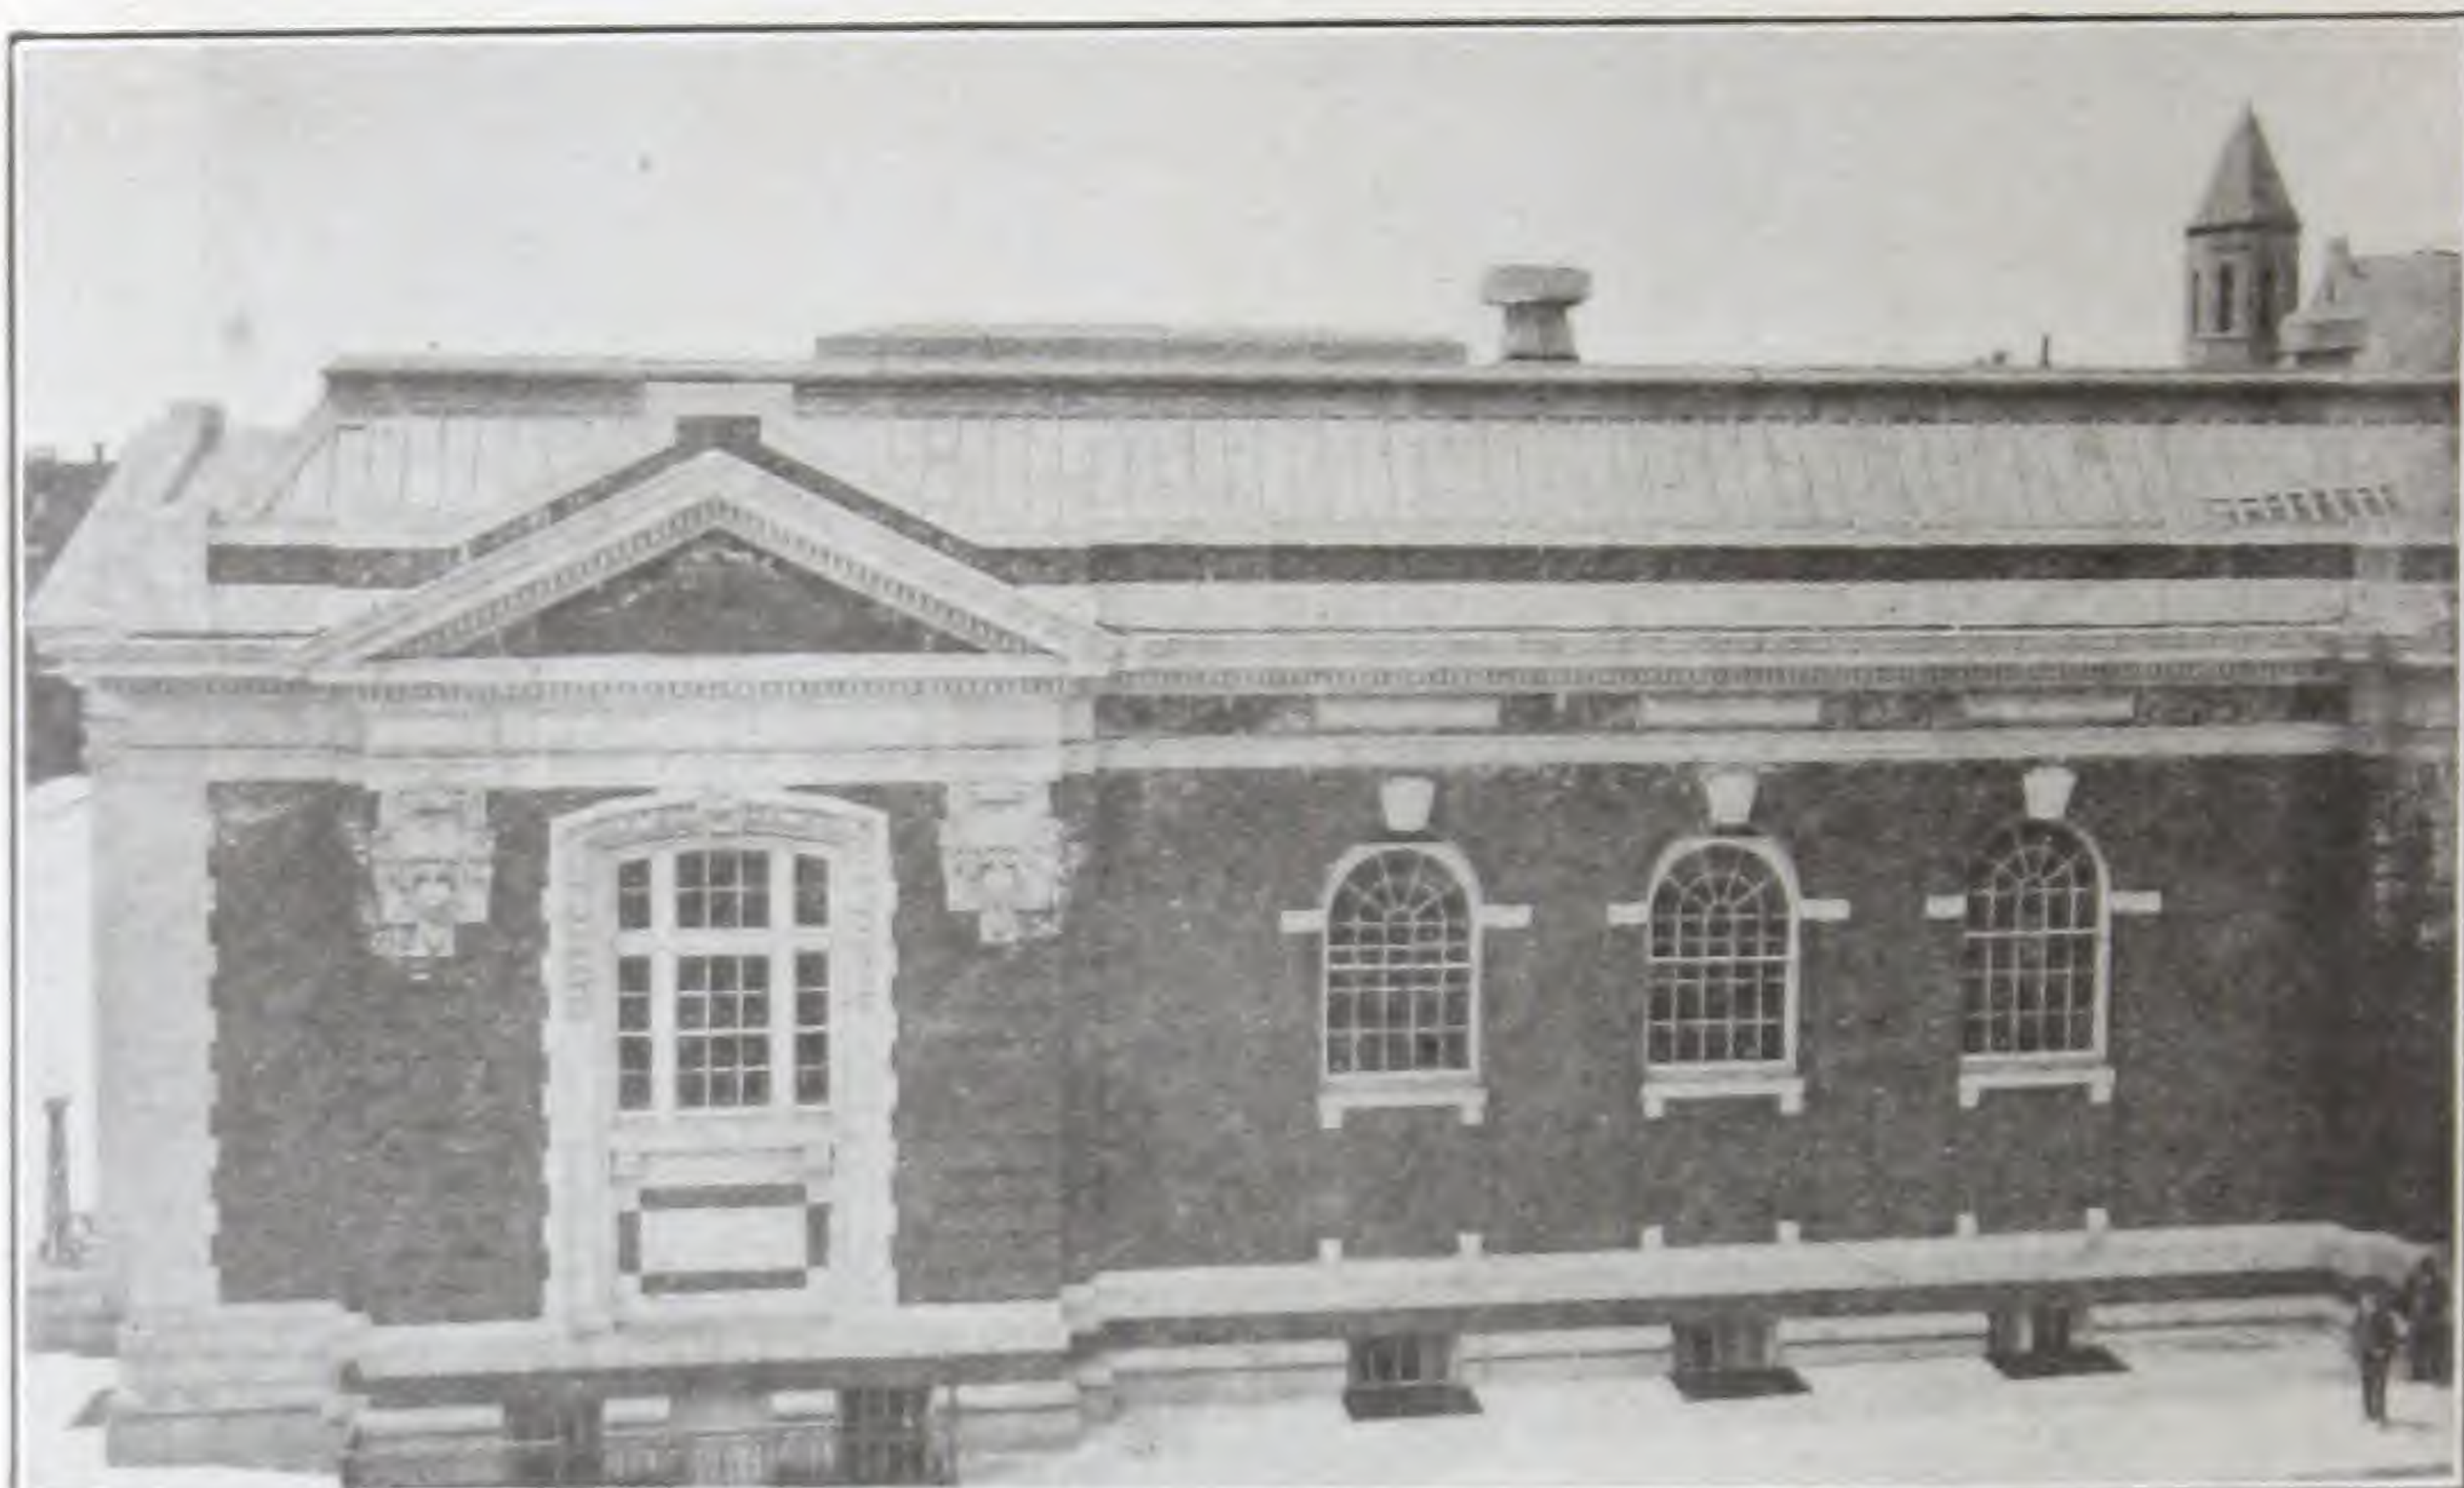
16. ADAPTABILITY: The Carnegie Library, at Frankford, Philadelphia. In this case the tin has been laid over half-round strips to give the desired ribbed effect.

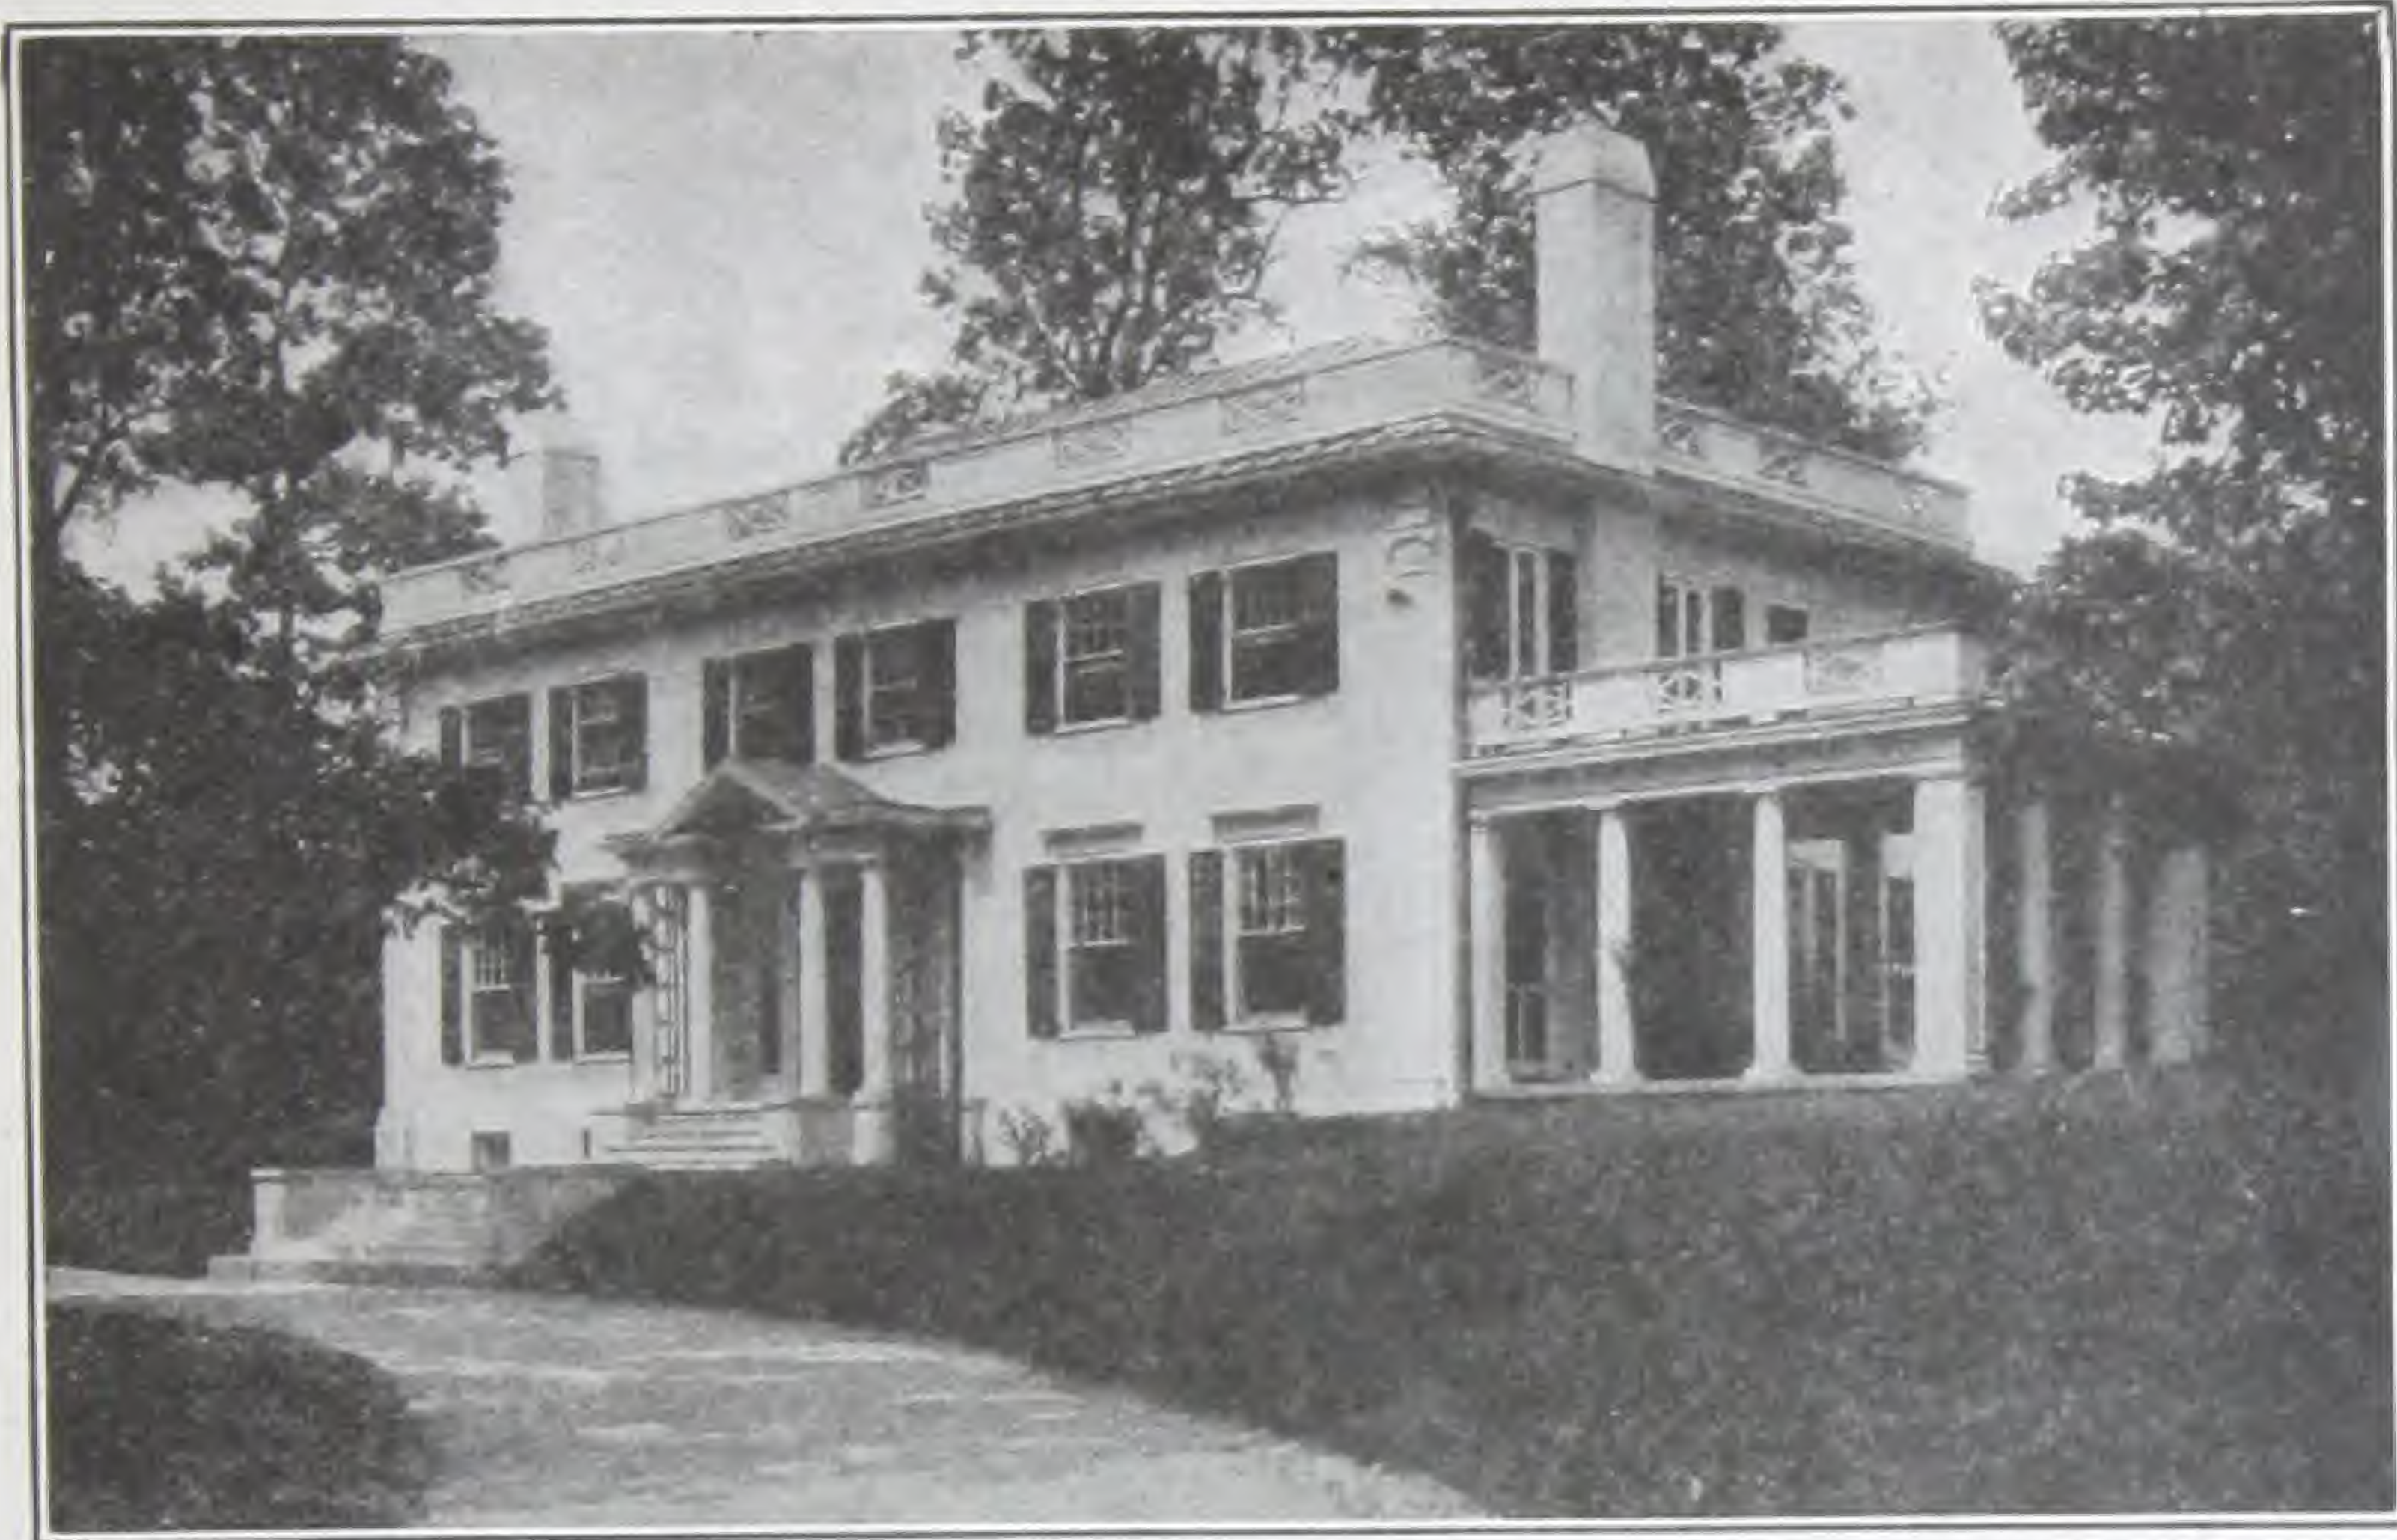
**17. ADAPTABILITY:** H. W. Blake's residence, Englewood, N. J. Illustrating the artistic use of good tin on a suburban residence. Note the neat appearance of the standing-seam tin roofing.

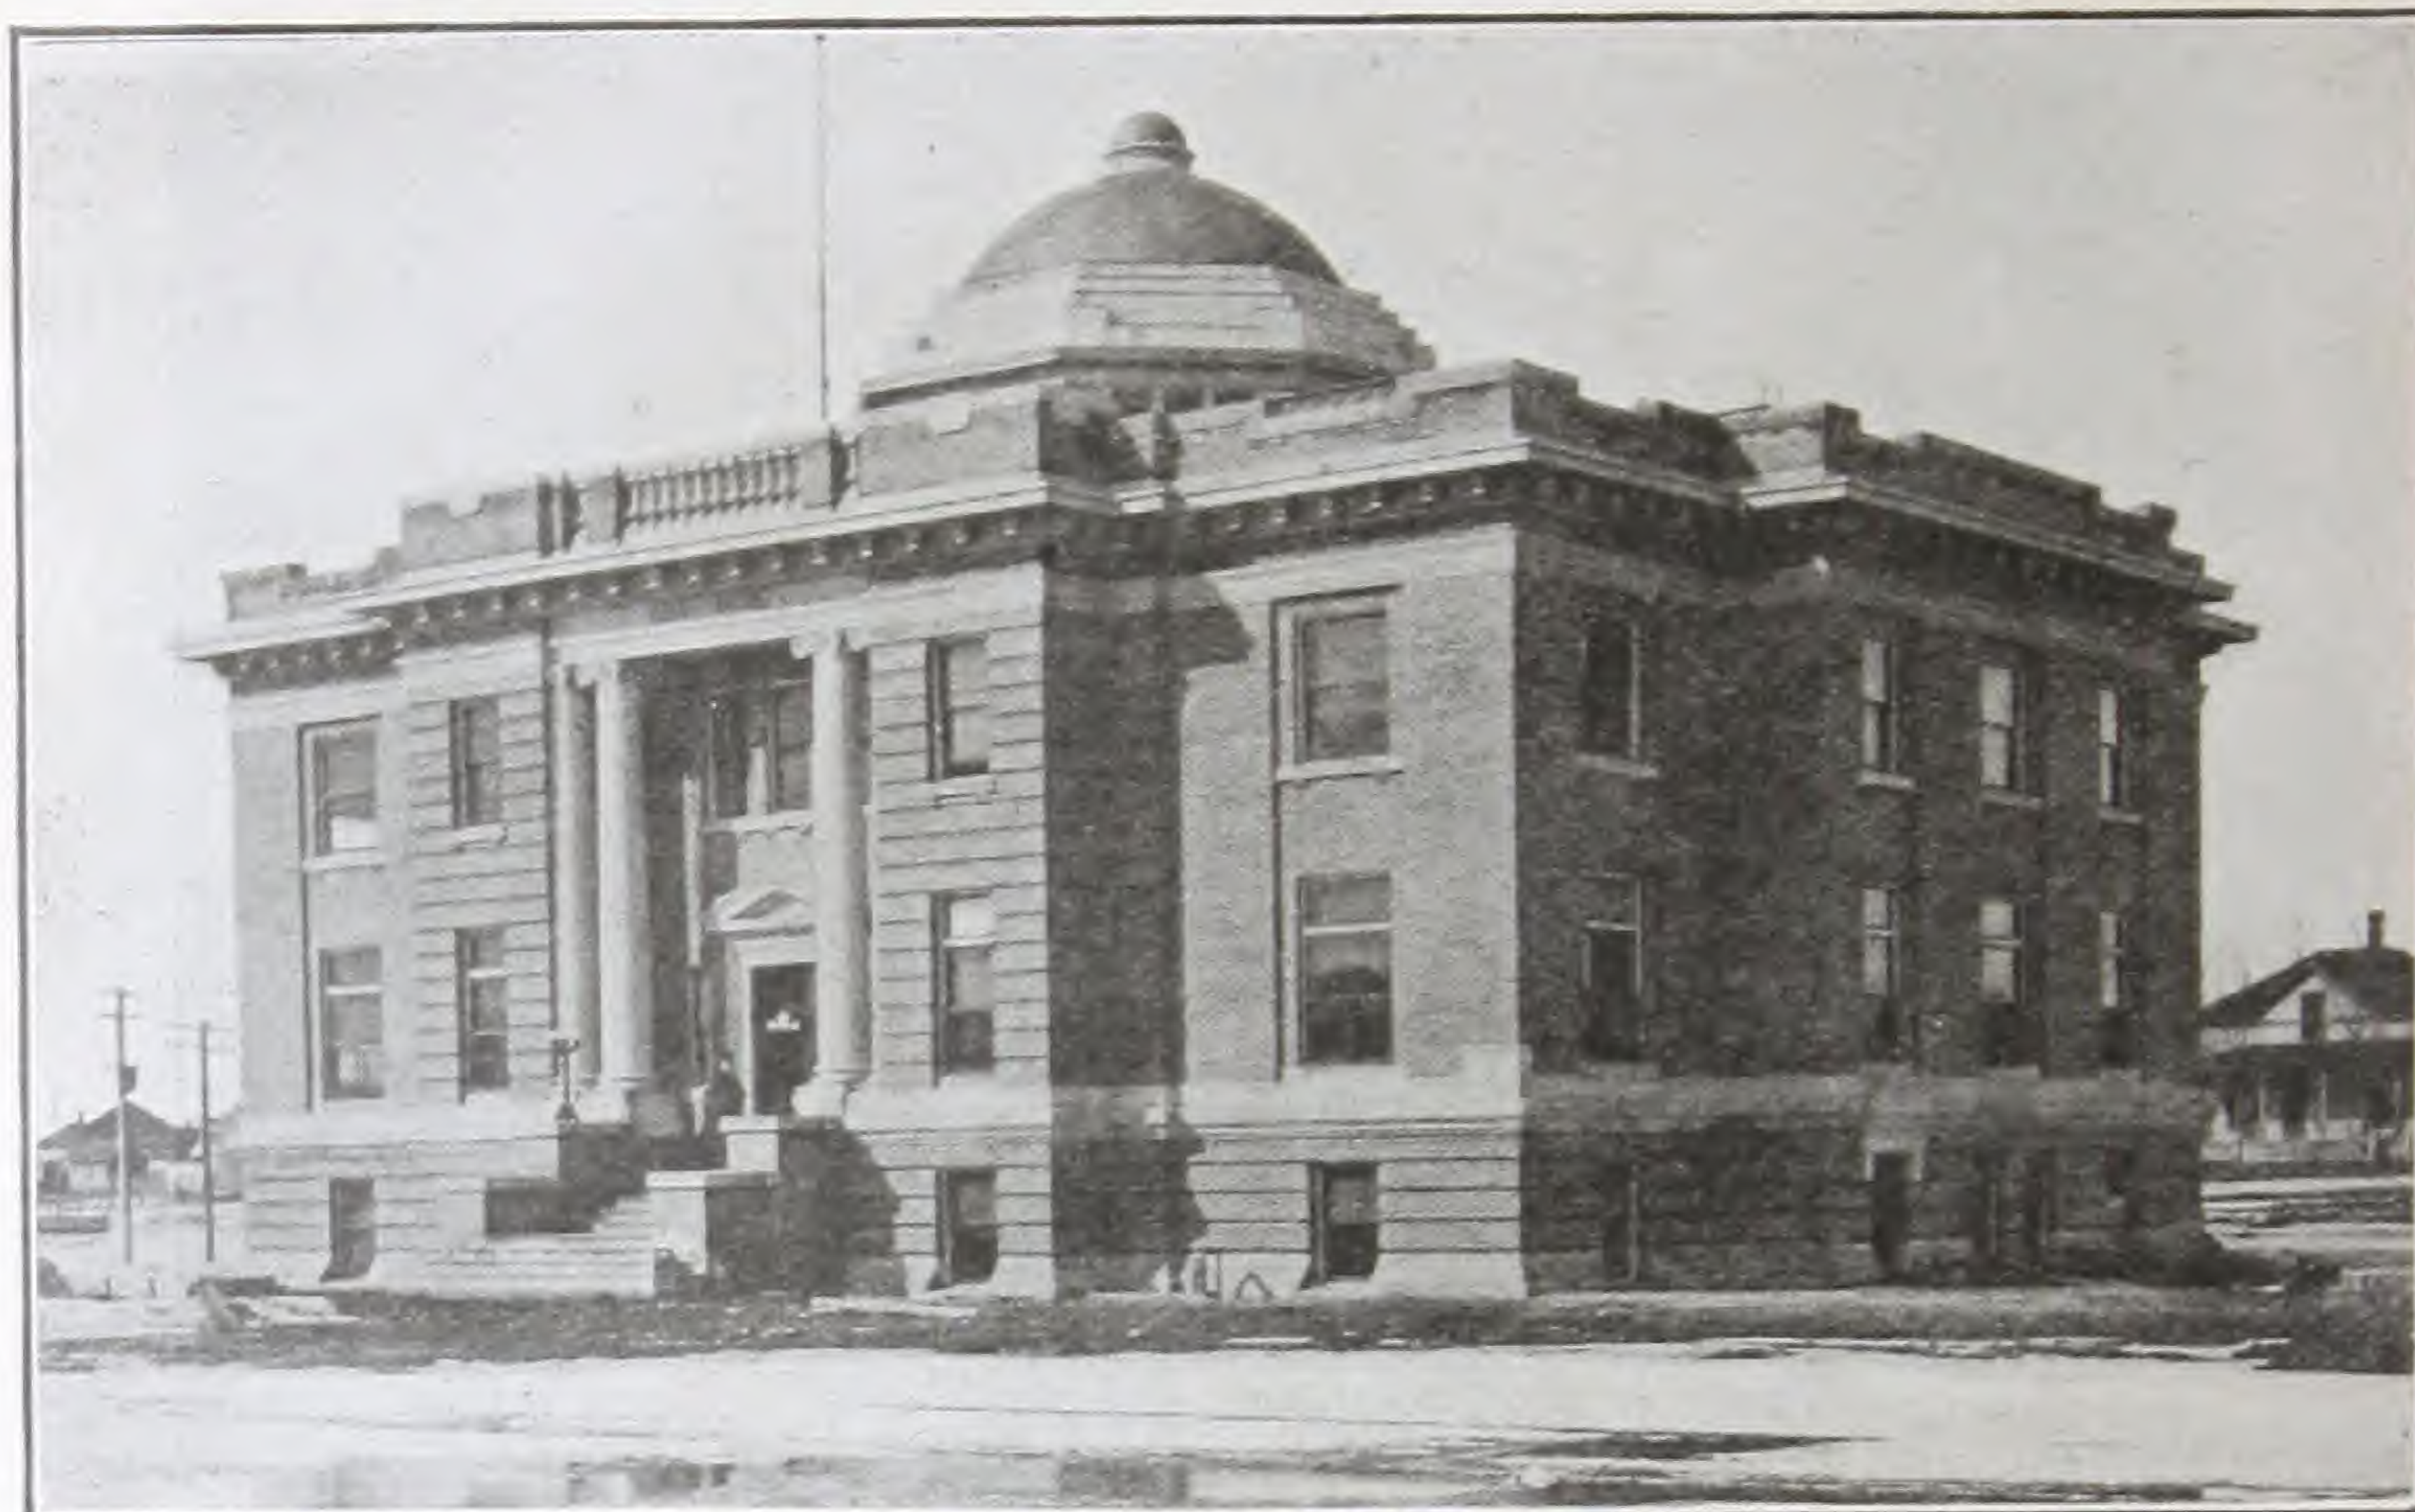
**18. ADAPTABILITY:** Fremont County Court House, St. Anthony, Idaho. Dome, steps, cornice, and surrounding roofs covered with good tin. Sheets laid horizontally, with perpendicular joints broken. Sheets cut slightly tapered, fitting closely to the curve of the roof.
